Thermography Inspection Report

Company	DeLorenzo Electric Inc.
Author	J C
Date	11th October 2011

Inspection 1 - Fall 2011 PPL-1

Operator	J C
Location	Mech. Room
Equipment	Power Panel #1

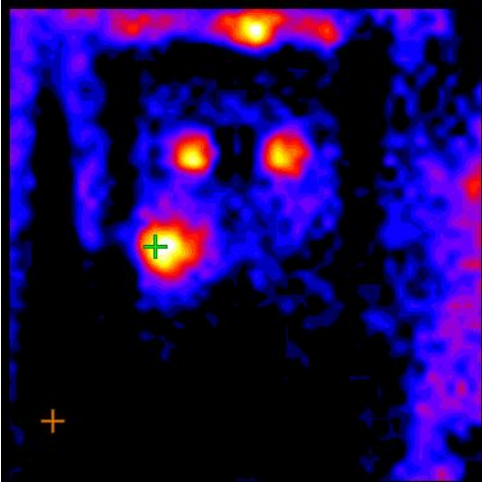
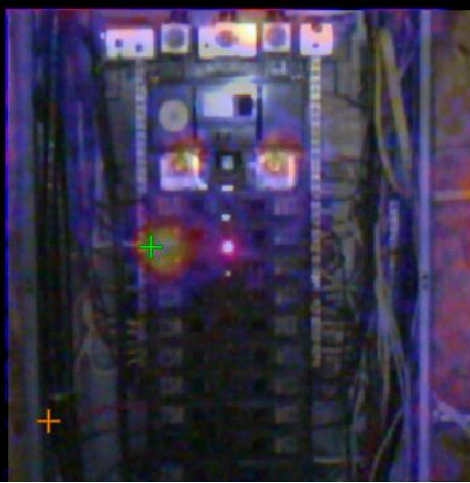
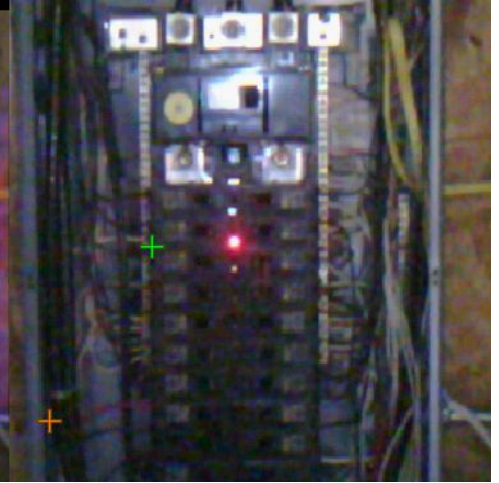
Greatest temperature rise is 4.9 degrees F

Cursor 1	70.4 °F
Cursor 2	65.5 °F
Difference	4.9 °F (Cursor 1 - 2)

No Faults found.
